## ***Failure of Bonded Natural Rubber Cylinders in Tension***

*This study describes modes of failure which may occur in bonded rubber blocks in tension. Aspects of cavitation failure and interfacial bond strength are discussed in vulcanisates containing different carbon loadings. The relationship between cavitation and bond failure on the ultimate failure stress is examined. Results indicate that the mechanism responsible for ultimate failure tends to change from one of debonding to cavitation as the carbon content is increased. The conditions required to initiate surface crack propagation and the effect of such cracks on breaking stress are also described.*

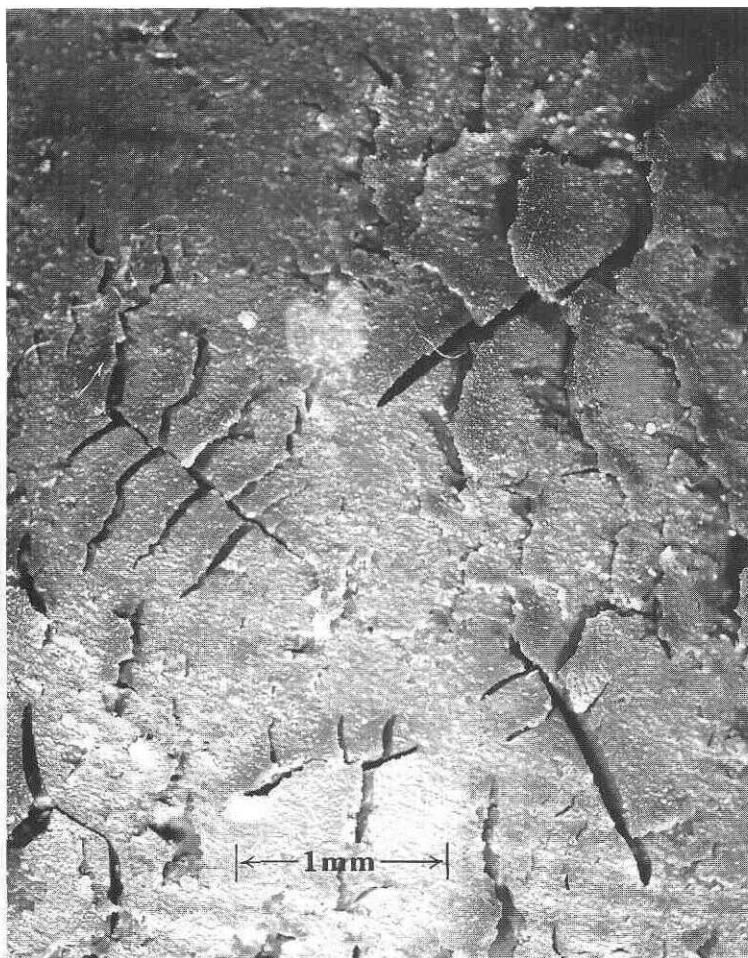
*Figure 9. A close-up view of cavitation cracks in a lightly carbon black filled vulcanisate (Compound 1). At a stress approaching break, secondary cracks can propagate from the primary cracks normally at an angle of approximately  $90^\circ$ .*

Sectioning of test pieces stressed almost to break indicated that, in some cases, further cracks develop from the major cracks. The additional cracks are normally regularly spaced, and tend to propagate from alternate sides of the primary crack at an angle of approximately  $90^\circ$ . An example of such crack development in a test piece moulded from *Compound 1* is shown in *Figure 9*.

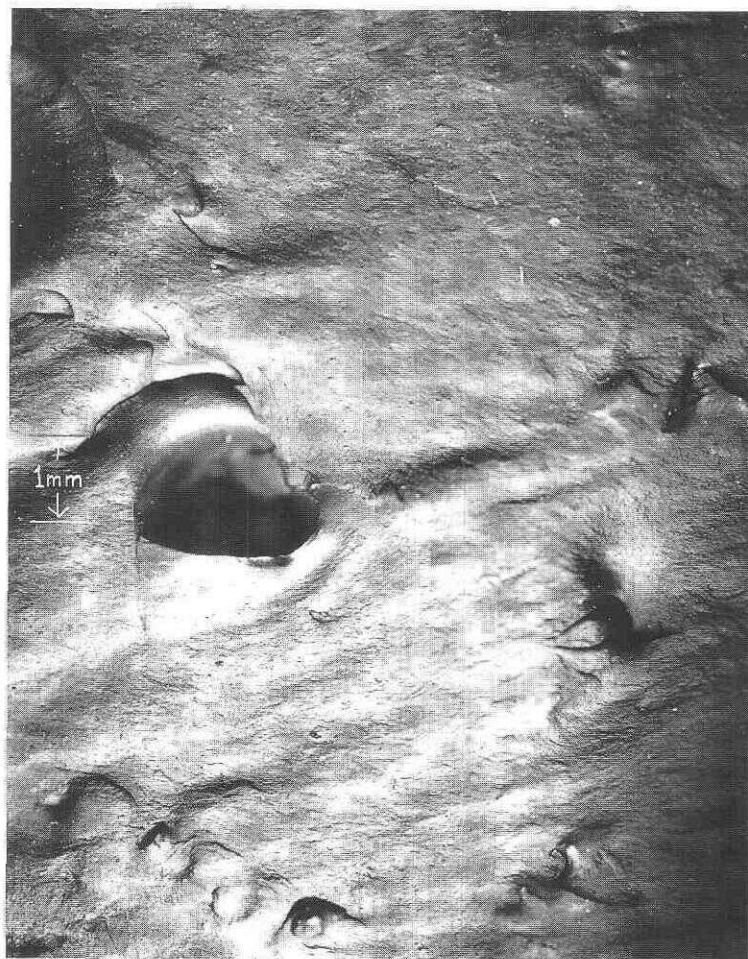
*Figure 10. A typical crack face and cavity in a highly carbon black filled vulcanisate (Compound 5) pulled to break. The crack face is relatively featureless when compared to an intermediate filled vulcanisate.*

The crack surface in vulcanisates with large filler loadings (80 p.p.h.r. N330) is quite different in appearance from those for unfilled or lightly filled compounds. Crack surfaces in highly filled vulcanisates (*Compounds 4 and 5*) do not show the characteristic contour lines found in unfilled and lightly filled compounds but rather, a comparatively featureless smooth surface. Such a surface is shown in *Figure 10* for *Compound 5*, with one of the few cavities observed in this vulcanisate. The often reported feature of 'knotty' tearing in natural rubber vulcanisates containing intermediate
