## *Electrochemical Degradation in Rubber*

T.J. POND\*#

*Micrographs are shown of some typical types of structural damage that can occur in a vulcanisate as a result of electrochemical degradation (ECD) in the material. The importance of the carbon black content, the operating temperature, the coolant composition, a vulcanisates cure system and other compound ingredients on the size of the current that can flow through a vulcanisate and its impact on ECD were discussed as well as the effects of crosslink density on volume resistivity and current flow. Results from SEM X-ray analysis of ECD damaged material on the depletion of zinc and sulphur by ECD and the associated effects on current flow through a compound are also discussed.*

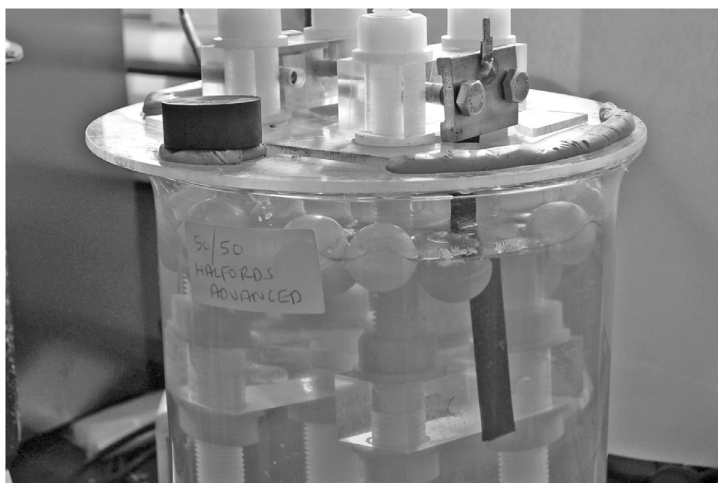
*Figure 1. A typical ECD beaker cell test apparatus partially filled with a coolant with a rubber test strip shown in the foreground attached to a fixing clamp for electrical connection.*

hose test apparatus. An example of a beaker cell apparatus is shown in *Figure 1* with a rubber test piece held in a clamp and partially immersed in a coolant fluid. Each beaker cell had two clamped test pieces spaced a set distance apart. These test pieces could consist of one metallic electrode and one rubber test piece or two rubber test pieces. Each test piece in a beaker cell consisted of a flat rectangular shaped sample of 100 mm by 10 mm and 2 mm in thickness cut either from moulded rubber sheet or metal sheet. A typical test procedure would be to clean and then weigh each test piece before fixing them in the metallic clamps and immersing in a coolant within the beaker with the coolant pre heated and maintained at the desired temperature. The voltage and current flowing across the test pieces would be continuously monitored throughout a test. Test pieces would again be weighed normally immediately following a test in order to determine the amount of weight change of a sample. The weight change of a sample can indicate the degree of swelling of the sample by the coolant which can be indicative of the amount of ECD damage in the specimen as ECD damaged material typically retains a substantial amount of fluid. Similar test pieces were also immersed in coolant under identical test conditions to the ECD tests, but without a flow of current, to provide a control for comparative mass uptake purposes. These control test pieces would normally show much less mass uptake than ECD damaged material. Sectioned test pieces were also prepared for SEM examination and micrographs taken of swollen and ECD damaged regions within the rubber. In the case of the tests with one metallic electrode and one rubber test piece the current and voltage flow was normally supplied by the potential difference generated between the two test pieces in the cell itself although a voltage could also be applied by an external power supply if desired. Where two rubber test pieces were present an external power supply was required to generate a

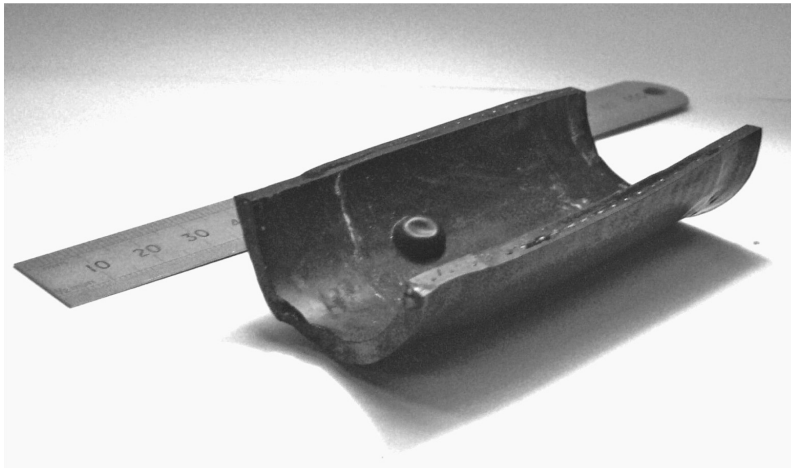
Figure 4. Showing a section of rubber hose after exposure to ECD. A “blister” has formed on the inner wall due to the ingress of liquid coolant into the rubber as a result of ECD.
